# WATER QUALITY MEMORANDUM

Utah Coal Regulatory Program

RE: 2009 Third Quarter Water Monitoring, Genwal Resources, Inc., Crandall Canyon Mine, Permit & Tracking #3377

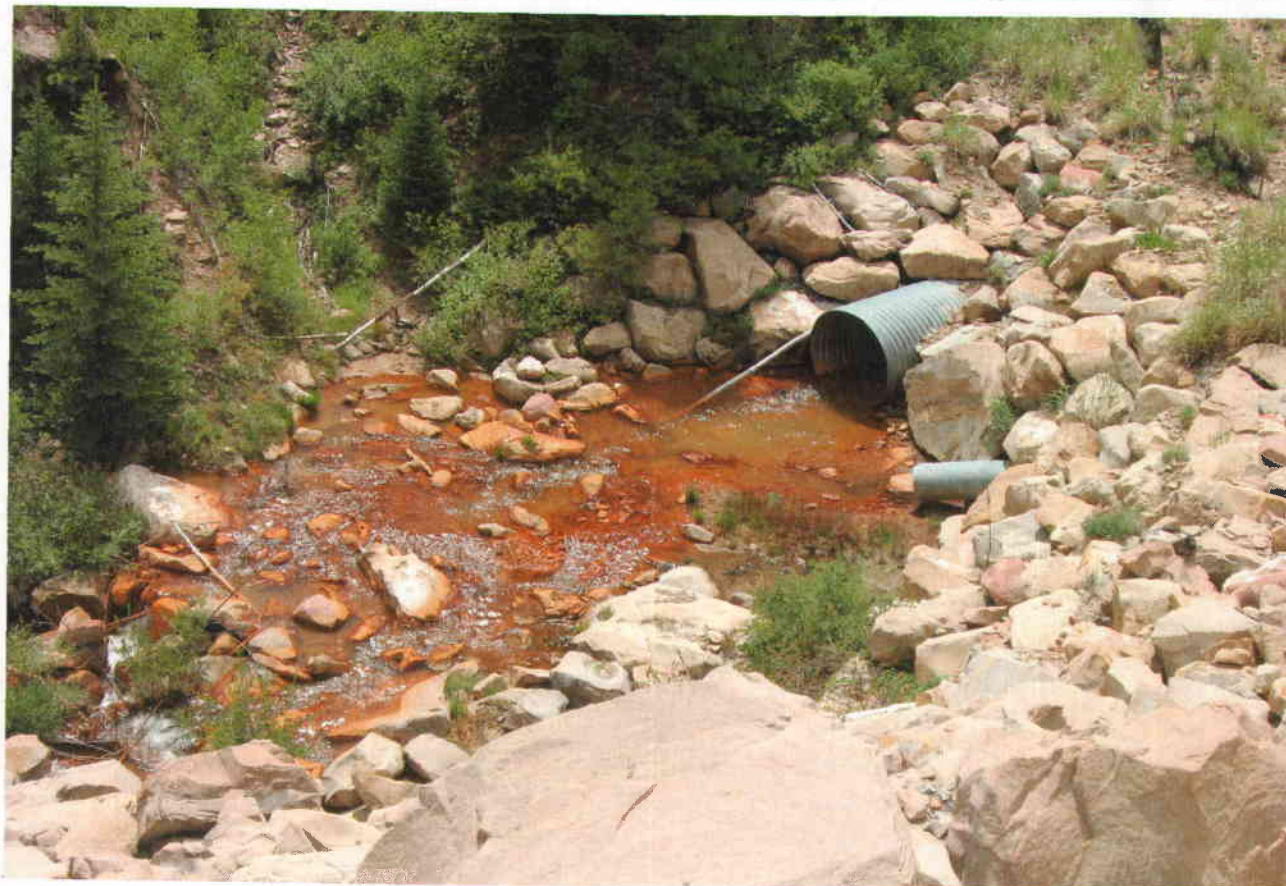
In addition, the stream channel of Crandall Creek has begun to show significant evidence of iron staining. The Division issued a Notice of Violation (NOV #10043) on August 10<sup>th</sup>, 2009 for failure to minimize disturbance to the hydrologic balance. DWQ issued a Narrative Standard Violation on August 10<sup>th</sup>, 2009 as well for the iron staining now evidence in the Crandall Creek stream channel.

*Iron Staining Visible in Crandall Creek Drainage at Outfall 002*

Work with other regulatory agencies in determining what if anything can be done to remove or mitigate the iron staining within the Crandall Creek stream channel (See Photos Below).

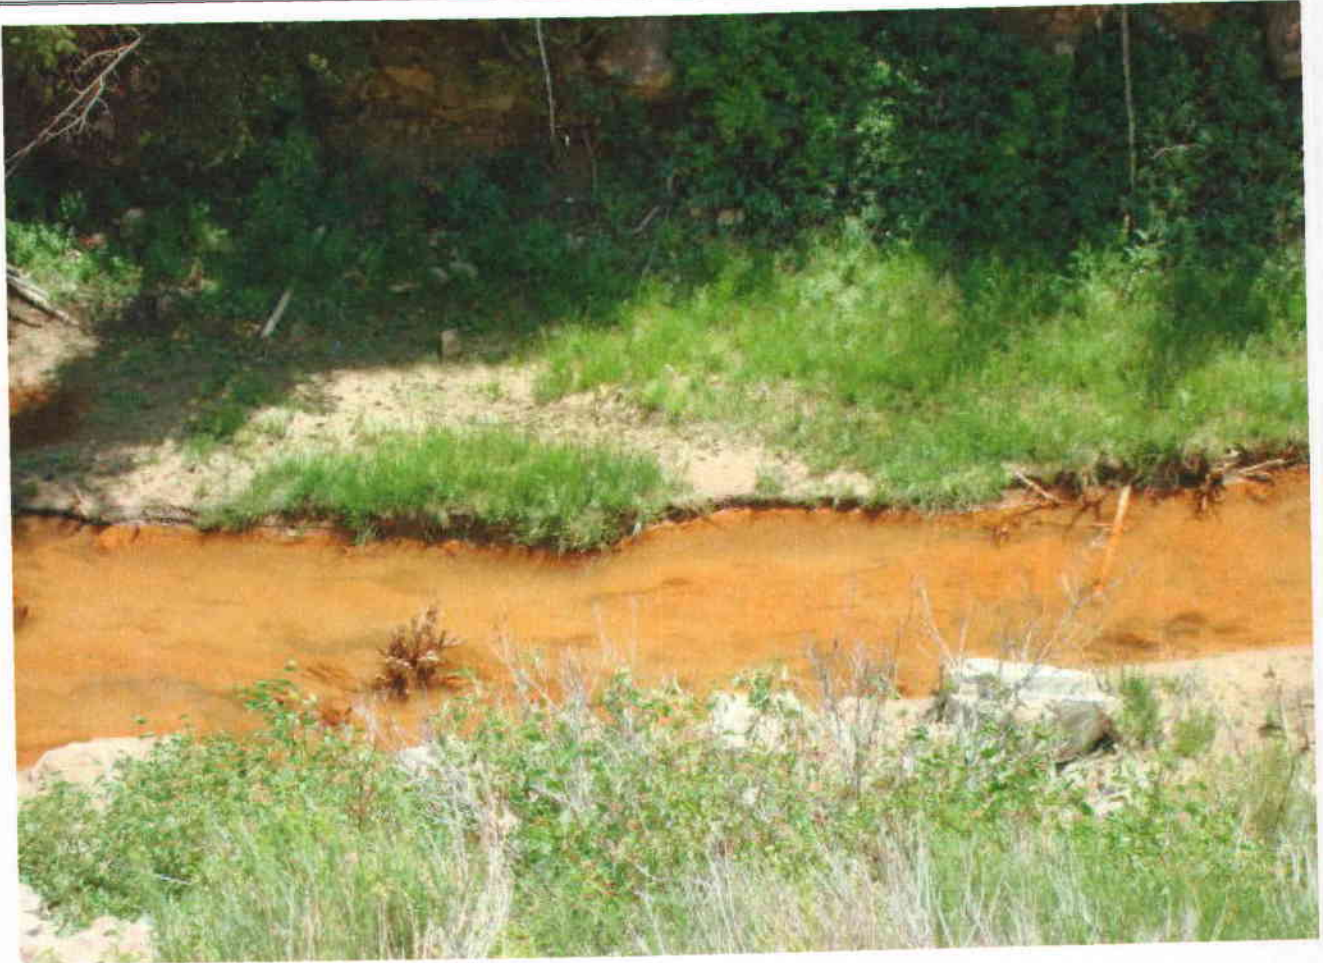
*Iron Staining of Crandall Creek Stream Channel Visible Downstream of Outfall 002*

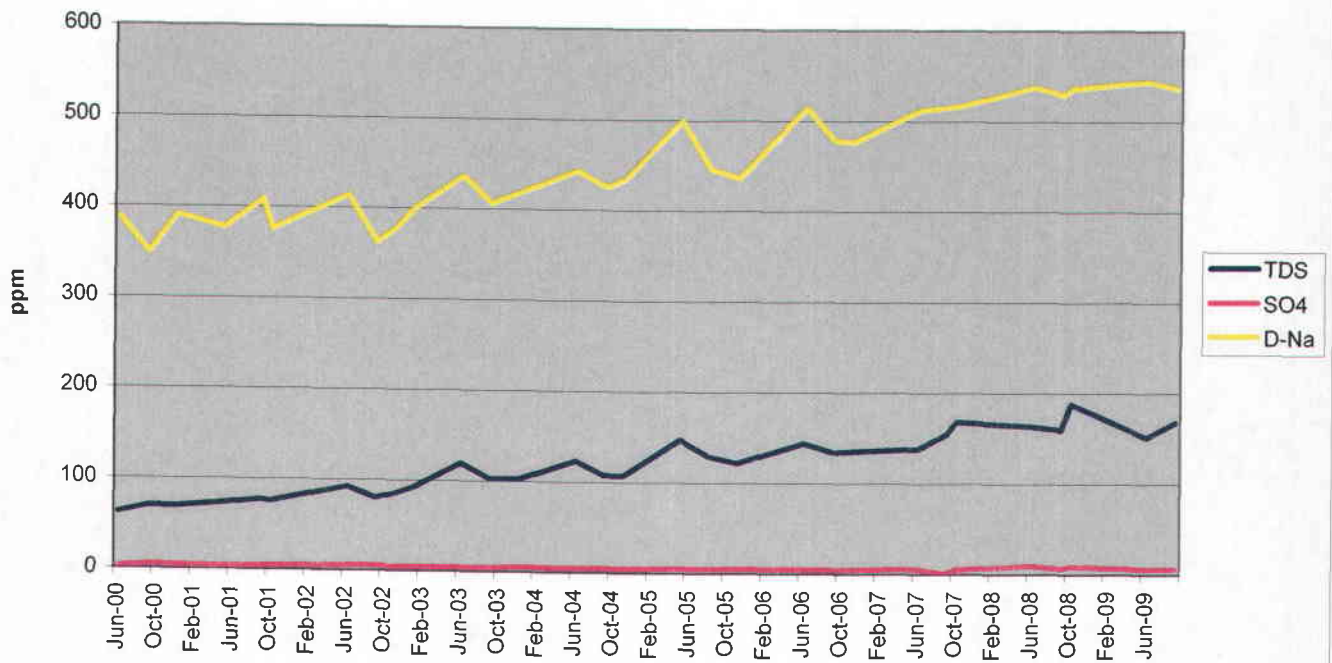
## Spring SP-58 Water Quality

Spring SP-58 had produced several analytical results that were outside 2 standard deviations: D-Na (2.72 standard deviations), SO4 (2.41 standard deviations) and TDS (2.01 standard deviations) during the 4<sup>th</sup> Quarter of 2008. However since that time, the aforementioned parameters appear to have stabilized to within a normal range as exhibited by the data set.

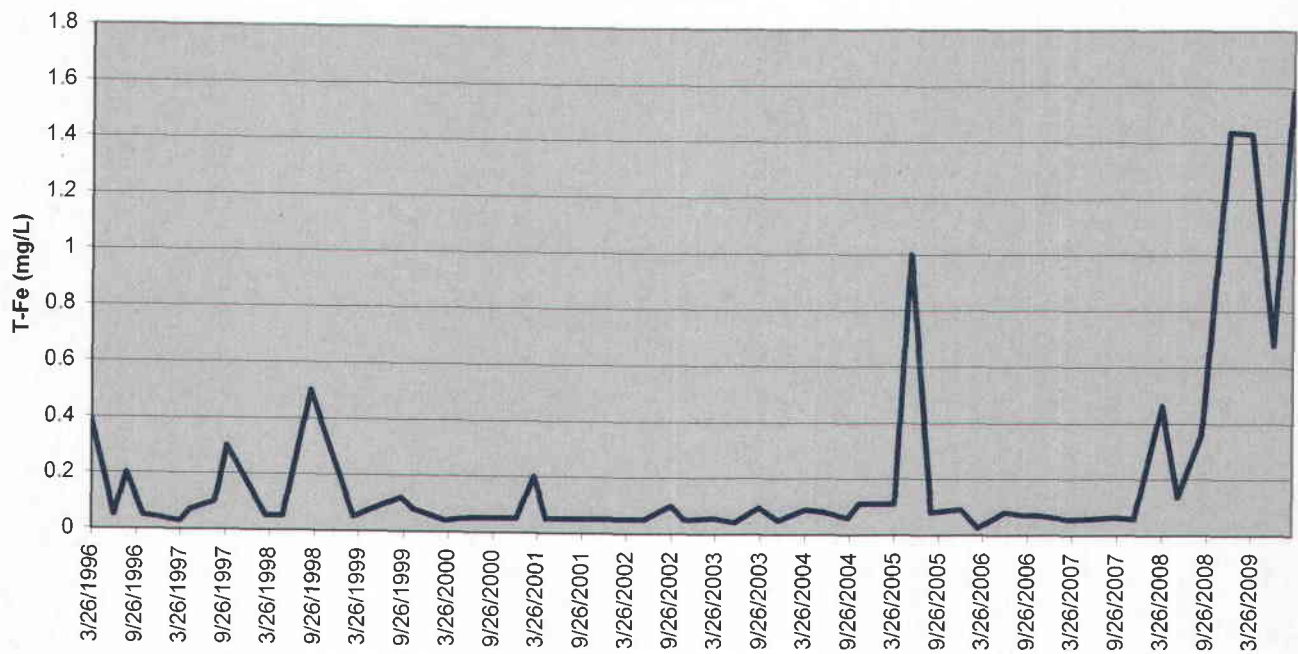
## Crandall Creek Lower Flume (LOF-1): Total Iron Levels

T-Fe levels measured below the mine facilities within the Crandall Creek drainage (Site LOF-1) rose significantly from the prior quarter continuing a weak upward trend that began during the 4<sup>th</sup> quarter of 2008 and 1<sup>st</sup> quarter of 2009 (1.438 ppm and 1.432 ppm respectively). The 2<sup>nd</sup> quarter of 2009 produced a T-Fe level of 0.679 at Site LOF-1. However, this quarter's results rose to 1.585 ppm. It would appear that the lower value obtained during the 2<sup>nd</sup> quarter of this year may have been an anomaly.

Maintain a close examination of T-Fe values within the Crandall Creek drainage (specifically surface water monitoring site LOF-1).

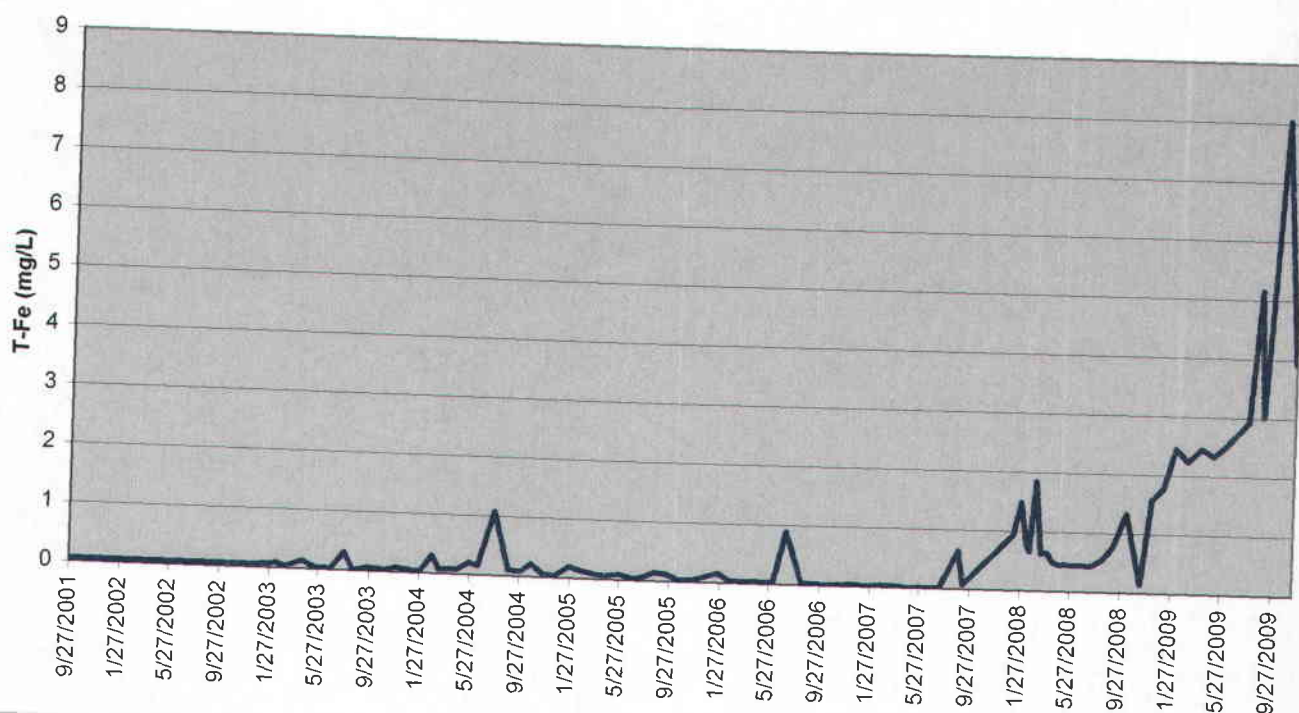
**Total Iron (T-Fe): Outfall 002**

The results from the 4<sup>th</sup> quarter of 2008 again produced levels of TDS below the UPDES standard of 1,200 ppm. However, T-Fe values had increased to levels beyond the 1.0 ppm range established in the UPDES permit (1.59 and 1.335 ppm respectively for 4<sup>th</sup> qtr., 2008). Mine-water analytical results for the 1<sup>st</sup> and 2<sup>nd</sup> quarters of 2009 were again a mixed bag of compliant TDS levels with elevated T-Fe levels.

The 3<sup>rd</sup> quarter of 2009 produced analytical data from Outfall 002 that follows the same trend as has been established in the last 4 consecutive quarters. TDS levels from three sampling events remained below compliance levels (743 ppm, 696 ppm and 707 ppm respectively). Conversely, T-Fe levels obtained from the three sampling events were all above the UPDES compliance level of 1 ppm (2.501 ppm, 2.331 ppm and 2.455 ppm).

Continue to work with the Permittee in identifying a mine-water treatment system that will effectively lower the T-Fe concentrations to compliant UPDES levels.
